# Manhole Inspection Summary

Manhole # S09WW\_014MH

Insp Date: **4/10/07 10:54 AM**

**Location** Address: **3504 CEDARDALE RD**

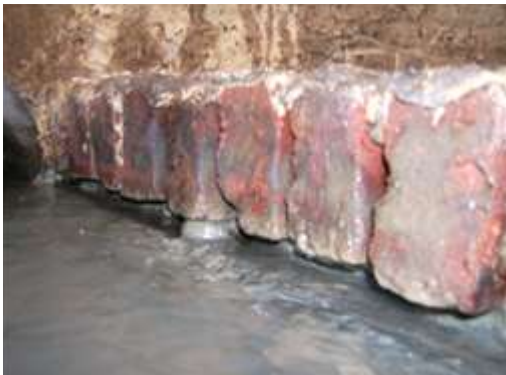
Defect 1

BENCH / AGGREGATE MISSING

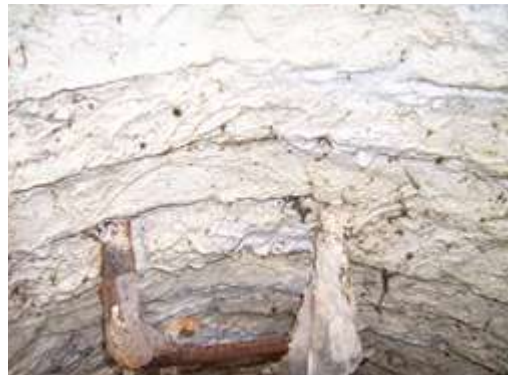
Defect 2

Count: **1** Missing: **0** ☒ **Corroded**

☒ **Evidence Of Surcharge** Depth: **3** (ft.) ☐ Active Surcharge Present

EVIDENCE OF SURCHARGE /  
CORRODED RUNG

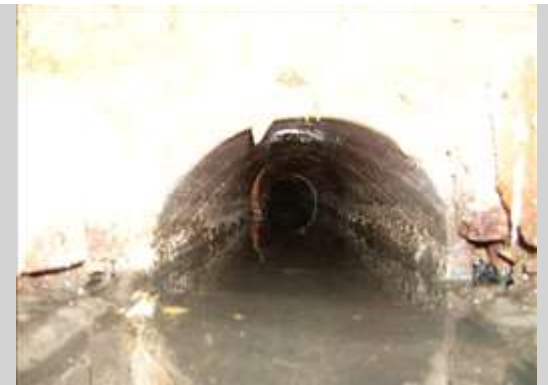
6 O'Clock Inflow

Pipe Height: (in.) Direct  
Pipe Material: **Clay** ☐ Pipe Lined  
Invert Depth: **6.04** (ft.) Flow Characteristics: **Slow**  
Deposits: ☐ None ☐ Mud ☒ **Sludge** ☐ Debris ☐ Grease  
Silt Depth: **1** (in.) Deposits Extent: **Light**  
Infiltration: **None** Pipe Seal Cond: **Sound**
